This article presents the results of an experimental study conducted to support the basic understanding of the rouging phenomenon that often occurs on stainless steel in WFI systems. With the established exposure technique, it is shown that rouging is affected by the surface quality and composition of gas atmosphere.

Using Exposure Tests to Examine Rouging of Stainless Steel

by Troels Mathiesen, Jan Rau, Jan E. Frantsen, Jorma Terävä, Per-Åke Björnstedt, and Benedikt Henkel

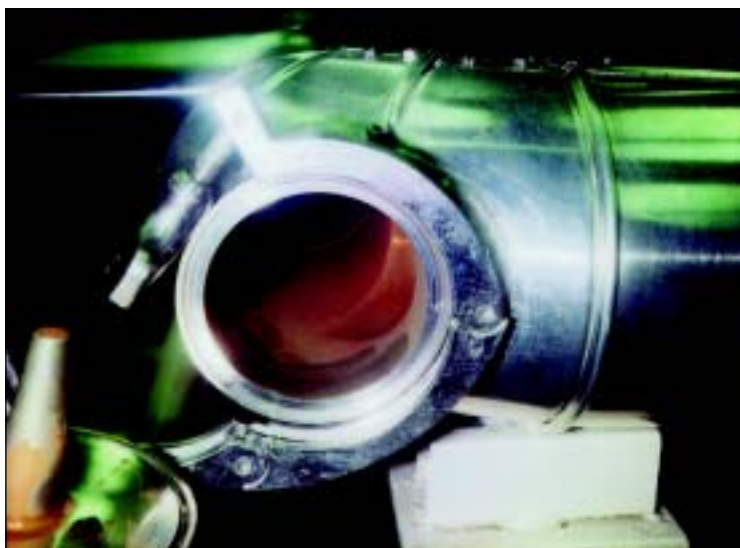
Figure 1. Rouging on the internal surfaces of a WFI system.⁵

For many years, numerous cases of red-brown to dark violet deposits on the inside surface of distillation columns, storage vessels, and distribution systems for hot purified water and clean steam have been reported. Due to the visual appearance, those deposits were referred to as *rouge*. Rouge was observed in pharmaceutical Water for Injection (WFI) systems, which are typically made of austenitic CrNiMo steel grade AISI 316L. The formation of rouge is promoted by elevated temperatures above 60°C - *Figure 1*.

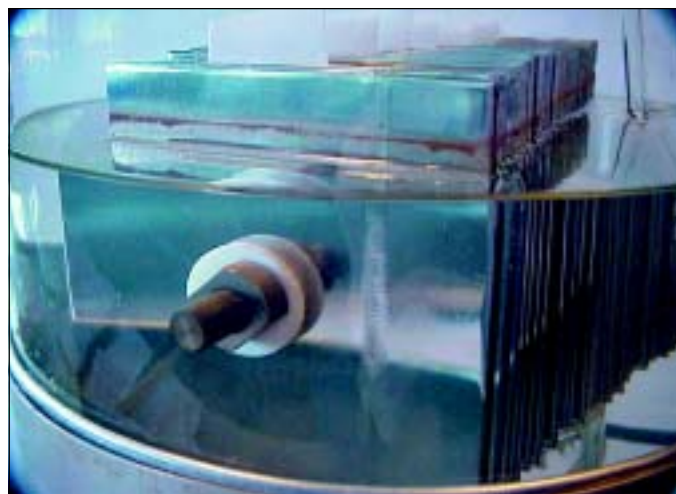
Figure 2. Test cell with a coupon rack showing rouge at the water line after three weeks of exposure in nitrogen purged WFI (boiling was paused). The coupons include both the #80 and the 2B+ep finish of 316L material.

The first signs of rouge became visible after four days of exposure while only little development was observed during the remaining exposure period. In all cases, rouge was seen as deposits along the water line of the coupons as shown in Figure 2. The most evident rouge formation was seen in the cells purged with nitrogen or air with addition of carbon dioxide. The

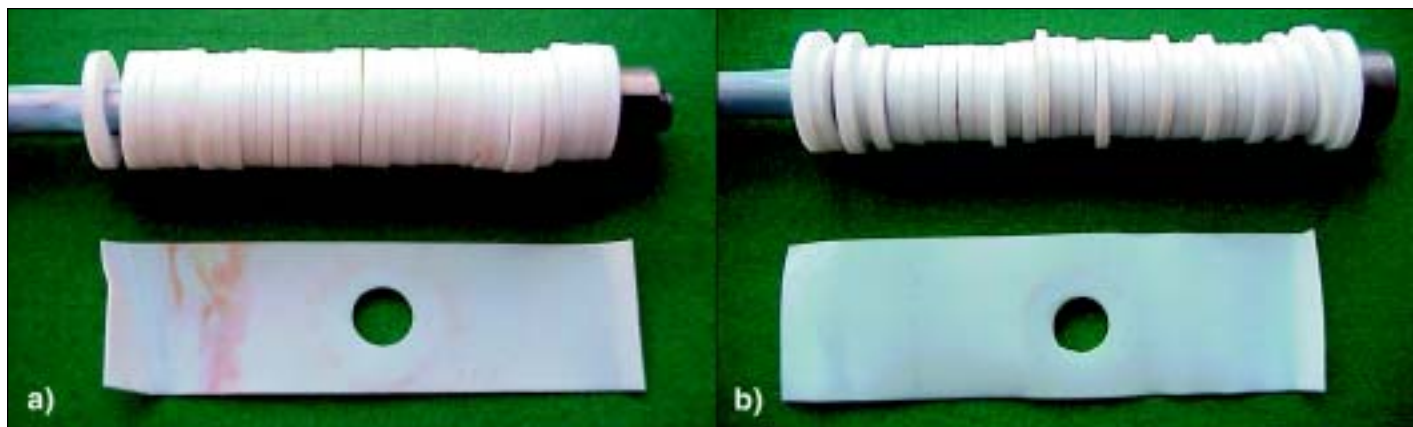
Figure 3. Teflon spacers and strips after exposure of 316L in WFI purged with a) air + 1% CO₂ and b) Air + CO₂.

two other atmospheres (air and air + CO₂) showed less or no rouge formation. This became clear when the coupons and Teflon strips were studied closely after dismantling the cells - Figure 3.

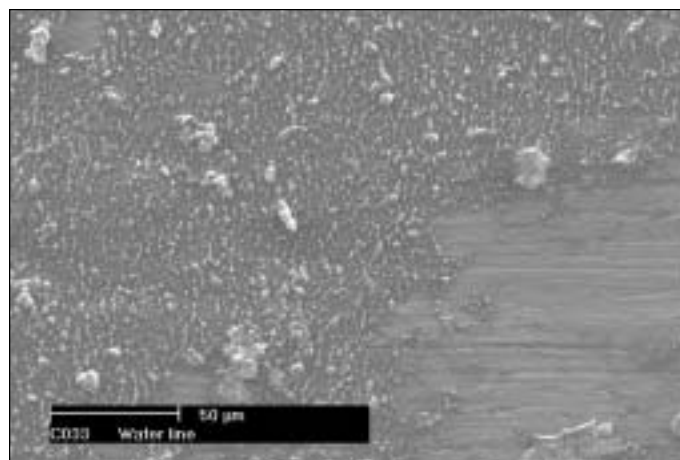
Figure 4. Exposed coupon covered by loosely adhered rouge deposits. Scanning electron micrograph.

the coupons showed that the rouge product consists of relatively loosely adhered particles - Figure 4. However, since the rouge was evenly distributed on the strips and coupons, the first series of tests did not allow any distinction between the different surface treatments.

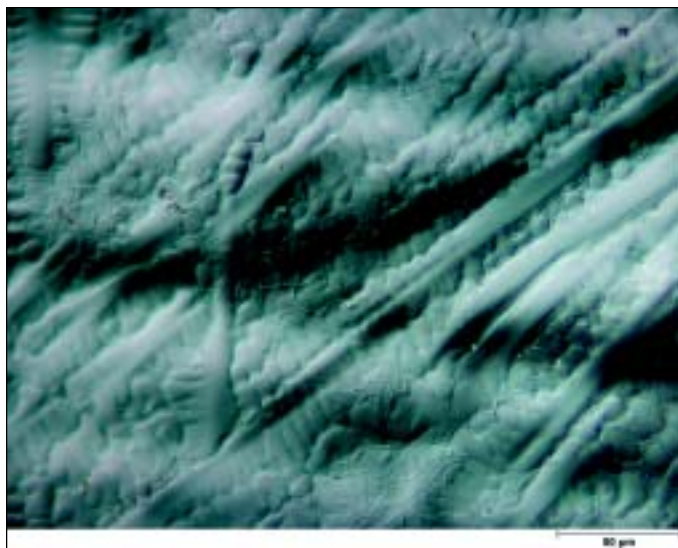
Figure 5. Weld metal of an electropolished 316L coupon. The picture was obtained by light microscopy and shows a small amount of delta ferrite distributed as a skeleton between the primary austenitic phase.
